INSPECTION REPORT

# SUMMARY

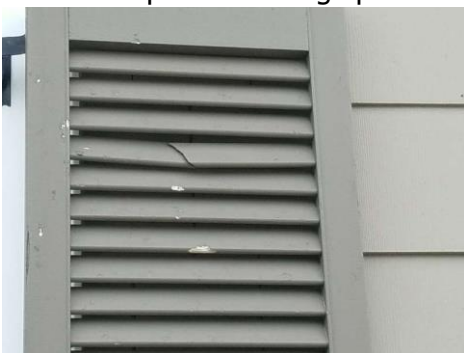
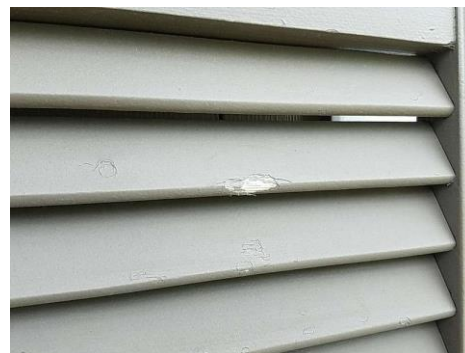
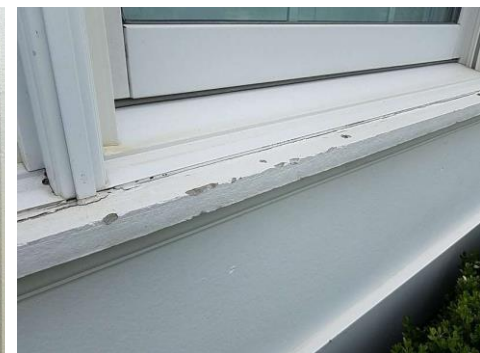
There are blemishes in the surface at several areas around the home (primarily on the front wall - west side facing directional weather). The blemishes are in the surface of the shutters and trim pieces. Wood surfaces should be repaired and painted to discourage deterioration. The blemishes on the trim pieces are mainly aesthetic and can be replaced as desired.

Contact a qualified siding specialist.

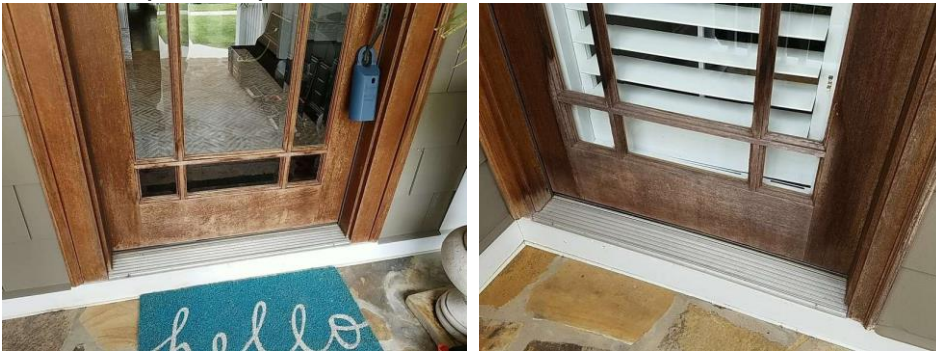
2.4.1 Exterior Doors

The stain is weak on the front exterior doors. This is normal to occur, especially for doors facing west and exposed to sunlight. The doors can be re-stained as desired.

Contact a qualified painter.

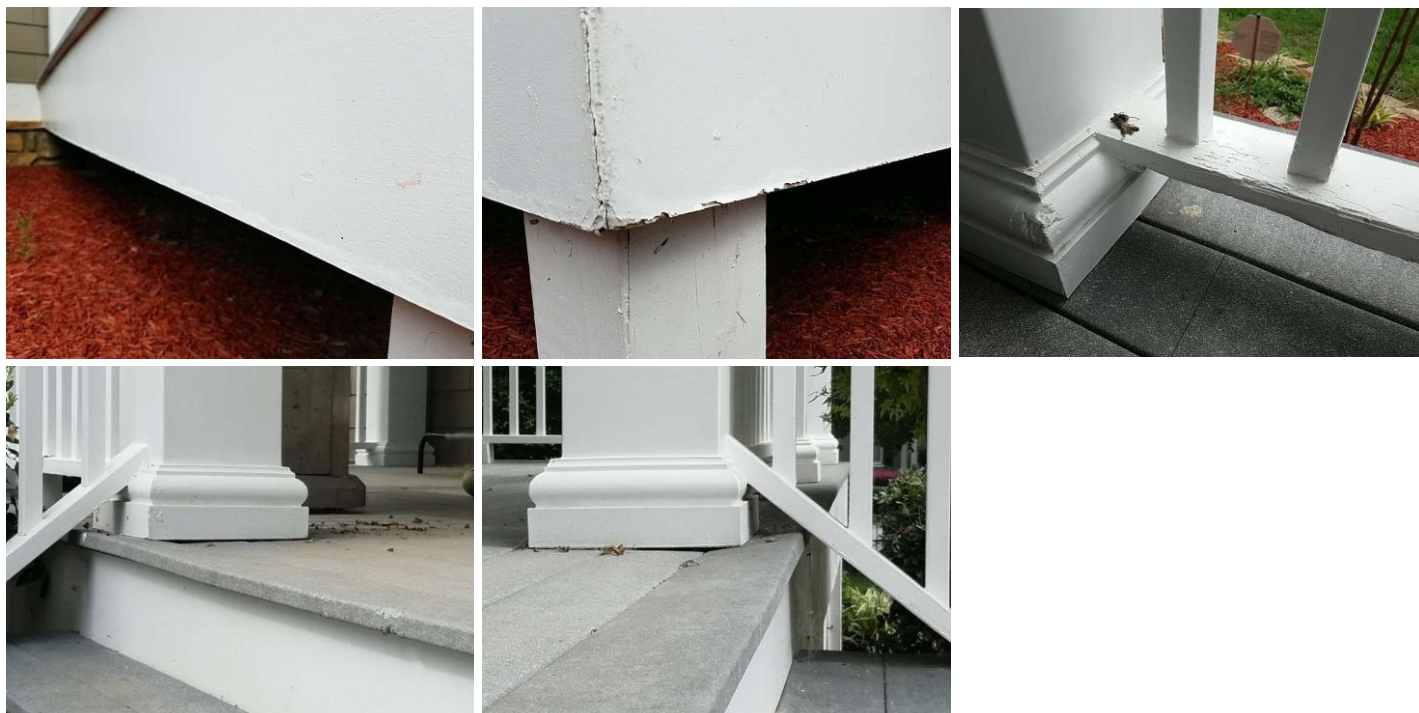
2.5.1 Deck

- The trim board along the outer perimeter of the deck is weathered. Re-painting the board can help to discourage deterioration.
- Some of the rails are scuffed (caused by pet/s).
- The surface is not level along the outer edge. There were visible issues with the framing below the outer end.

These items do not affect functionality or integrity and can be repaired or addressed as desired.

Contact a qualified deck contractor.

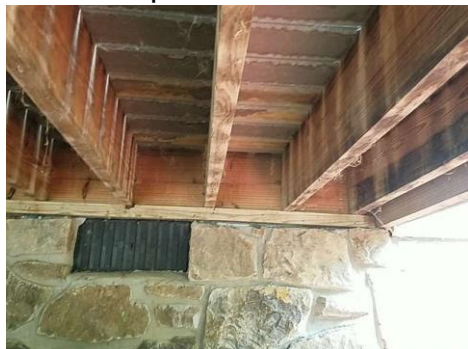
2.5.2 Deck

**LEDGER NOT BOLTED**

Contact a qualified deck contractor.

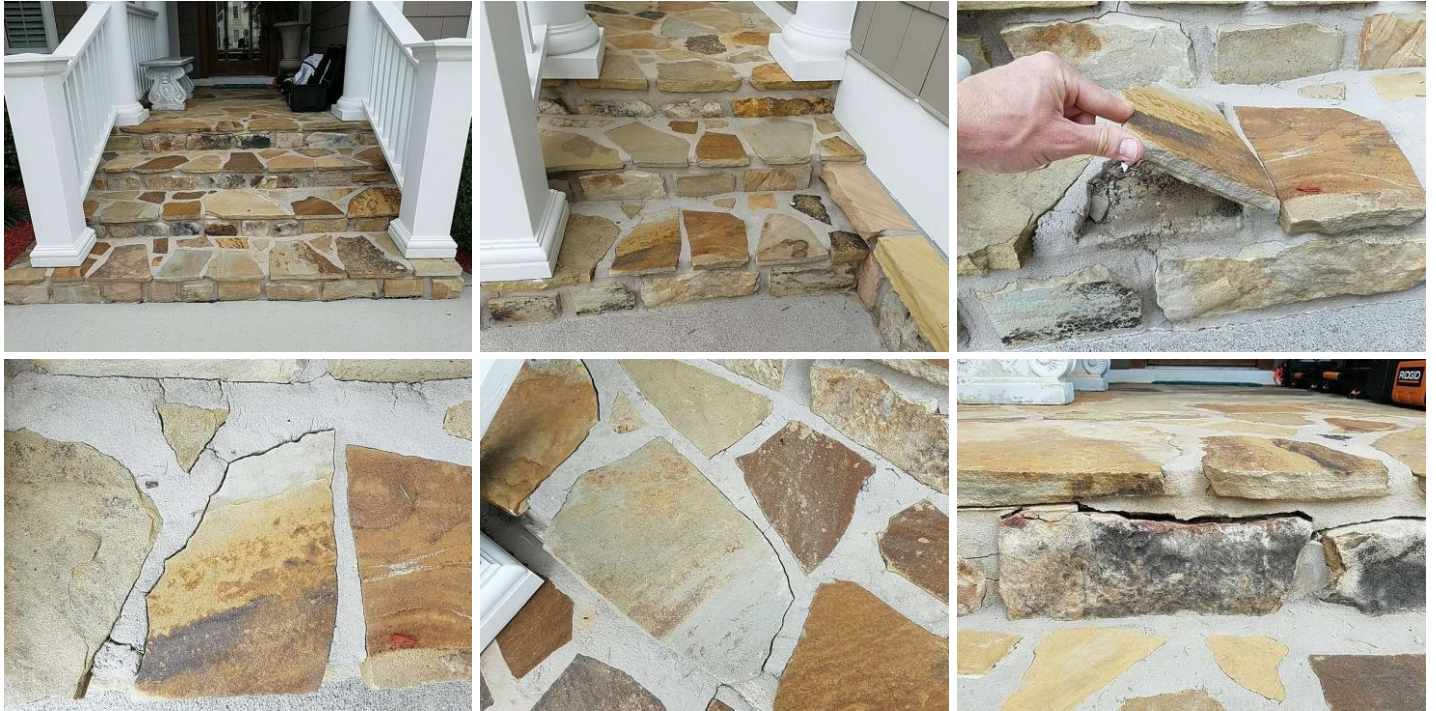
Some of the stones are loose at the porches on the front of the home. In addition, there are cracks in the mortar between the stones at various locations. All loose stones should be properly secured and any open joints in the mortar should be sealed to discourage further deterioration.

Contact a qualified masonry professional.

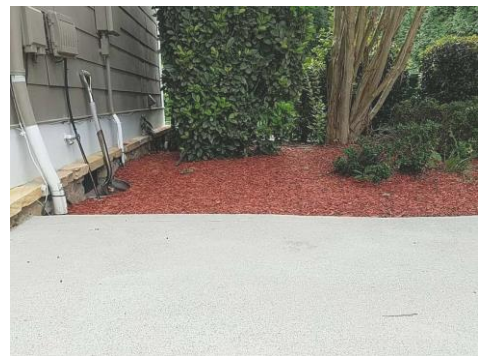
4.4.1 Grading and Drainage

Areas of the soil do not maintain proper slope away from the foundation. This could allow surface water to flow towards the foundation. All areas of the soil around the home should slope away from the foundation to encourage proper drainage away from the structure. If proper grading cannot be achieved, alternative means of drainage may be necessary (surface drain, french drain, etc.).

Contact a qualified grading contractor.

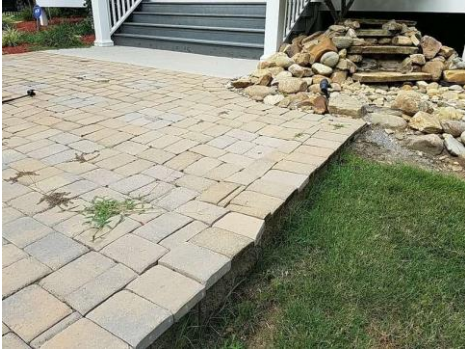
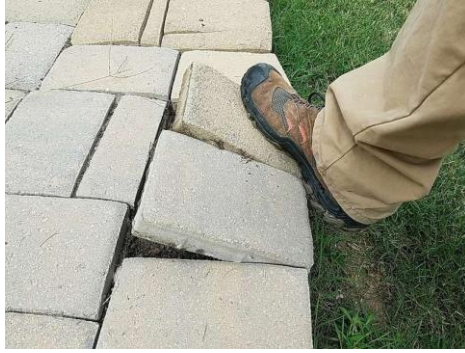
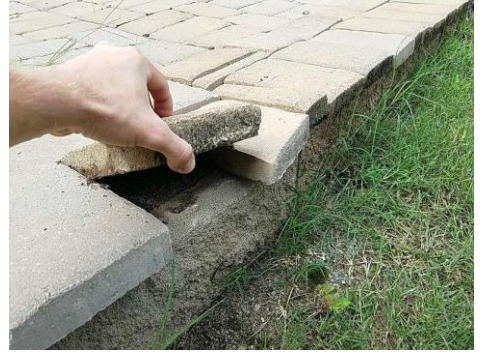
4.5.1 Patio

Some of the pavers are loose along the edge of the patio. This is a potential trip hazard. I recommend all pavers be properly secured.

Contact a qualified general contractor.

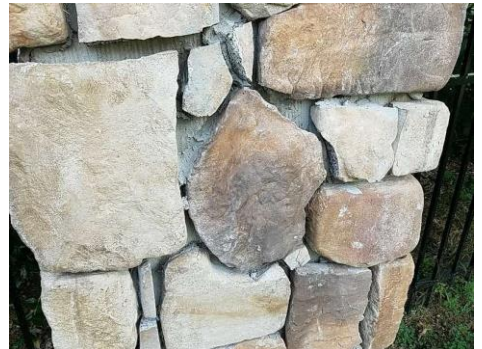
The stonework is incomplete on the columns for the fence. Some of the stones have come loose and there is no mortar between the stones.

Contact a qualified masonry professional.

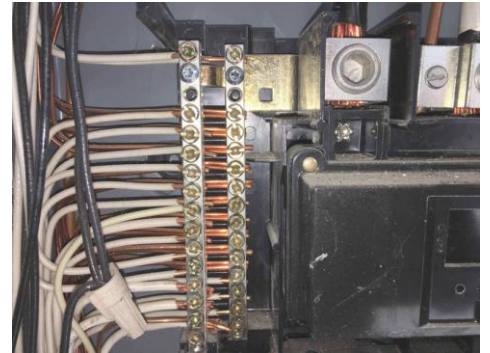
5.3.1 Distribution Panel

This item does not affect functionality of the system and can be repaired as necessary (in context with other electrical repairs that may be performed).

Contact a qualified electrical contractor.

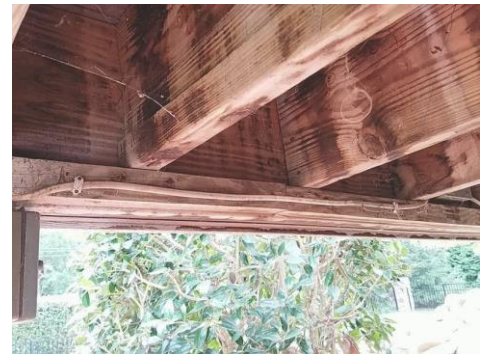
5.4.1 Branch Wiring

The wire at the listed location is not contained in conduit. This may result in damage to the wire and is a potential shock hazard if the wire is damaged. I recommend all exterior wires be contained in protective conduit.

Contact a qualified electrical contractor.

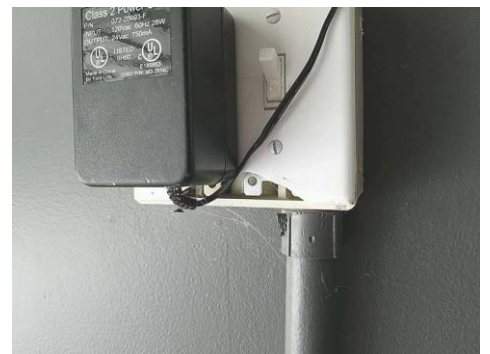
5.5.1 Fixtures

Cracked / broken cover plates were observed on the electrical fixtures. NOTE: I recommend replacing damaged covers.

Contact a qualified handyman.

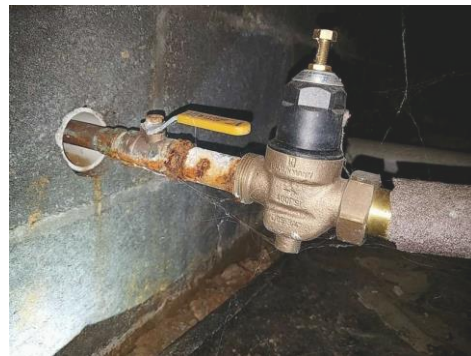
There is corrosion on the water piping at the listed location. The affected pipe should be replaced to ensure prevent undetected leaks.

Contact a qualified plumbing contractor.

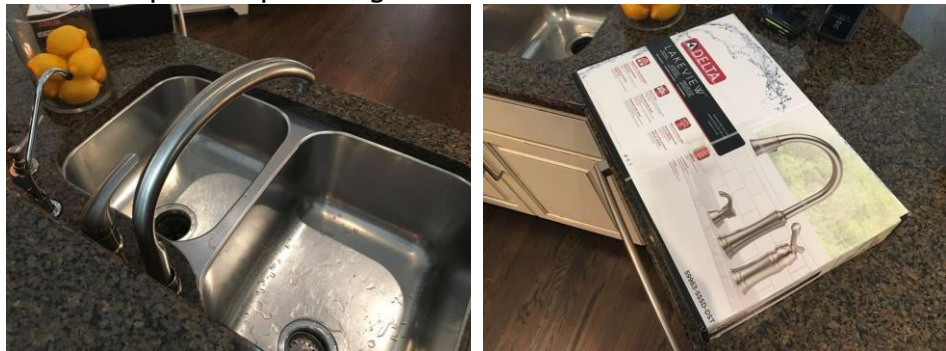
7.5.1 Kitchen Sink

The kitchen sink faucet is broken. A new faucet is intended to be installed prior to closing.

Contact a qualified plumbing contractor.

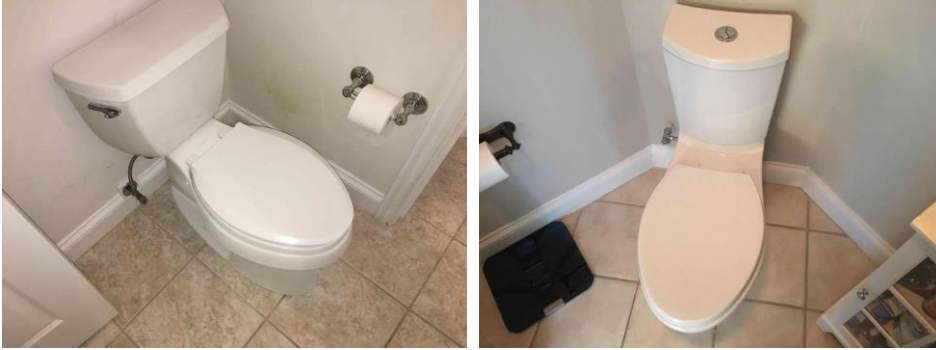
7.6.1 Bathrooms

The toilet is not secured tightly to the floor at the listed location. This raises potential for leaks at the seal. Necessary repairs should be made to secure the toilet and ensure there are no leaks or underlying concerns.

Contact a qualified plumbing contractor.

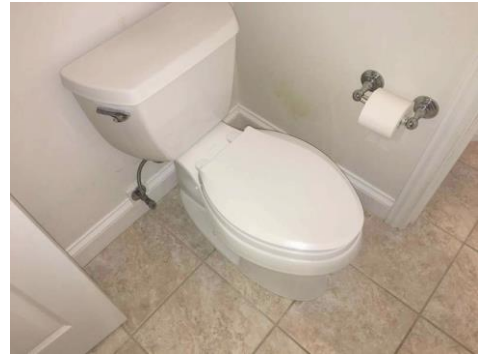
7.6.2 Bathrooms

The water continuously runs at the toilet at the listed location. The internal components will need to be repaired / replaced.

Contact a qualified plumbing contractor.

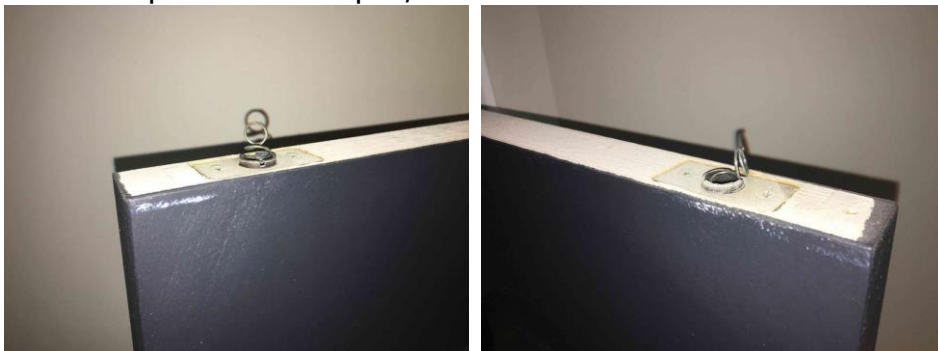
The ball hinge is broken on the door in the master bathroom. The hinge will need to be repaired / replaced.

Contact a qualified door repair/installation contractor.

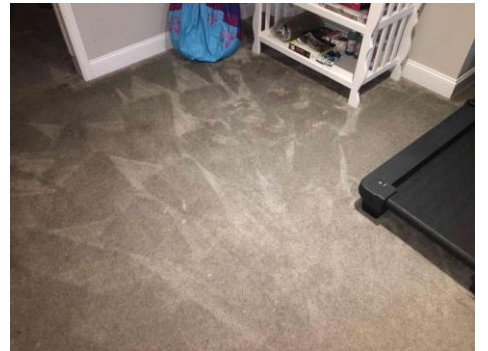
8.5.1 Floors

The carpet is stained at various locations. The carpet can be cleaned or replaced as desired. NOTE: Some stains may not be able to be removed.

Contact a qualified flooring contractor

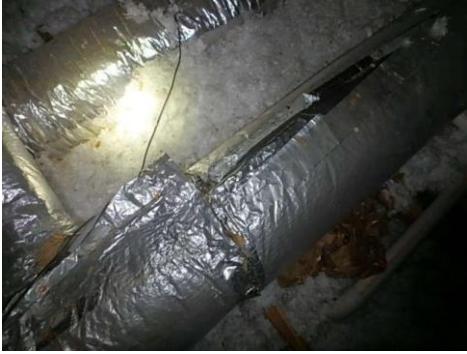
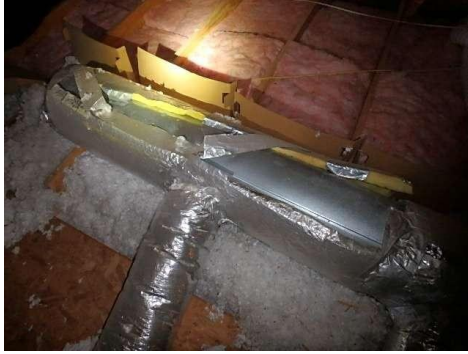
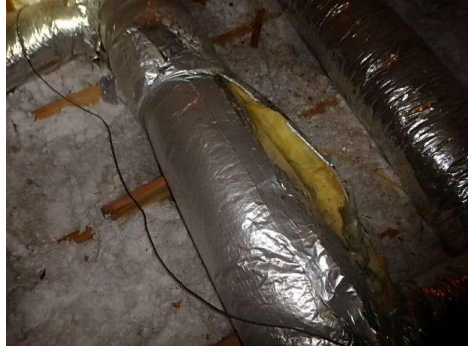
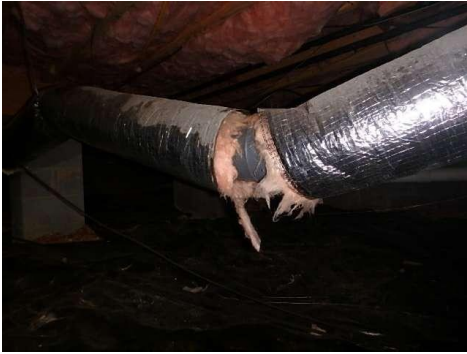
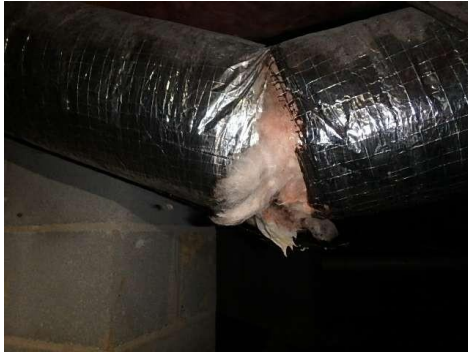
The insulation is loose / torn on sections of the air ducts at the listed locations. The insulation on the ducts should be repaired.

Contact a qualified HVAC professional.

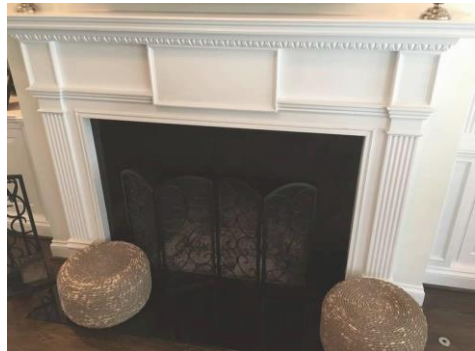
9.4.1 Fireplace

I recommend having the fireplace flue professionally cleaned / swept.

Contact a qualified fireplace contractor.

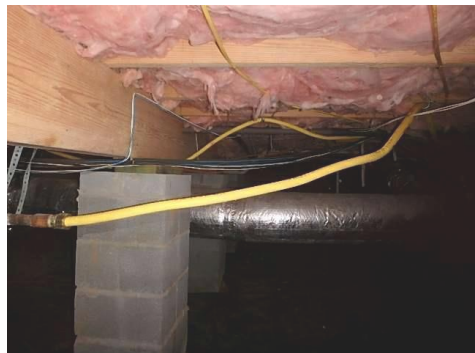
9.5.1 Gas Service and Piping

There is CSST gas piping routed in the home. This type of piping is required to be bonded to the main grounding system. You can read more about this type of piping at [this link](#). I recommend contacting a licensed electrician to verify the piping is properly bonded to the main grounding system as suggested by the pipe manufacturer.

Contact a qualified electrical contractor.

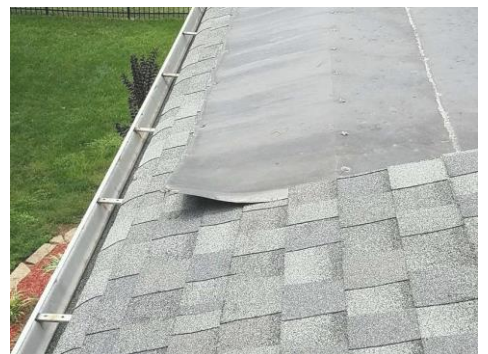
The bottom edge of the metal is loose at the rear of the home. The metal should be properly repaired to prevent leaks.

Contact a qualified roofing professional.

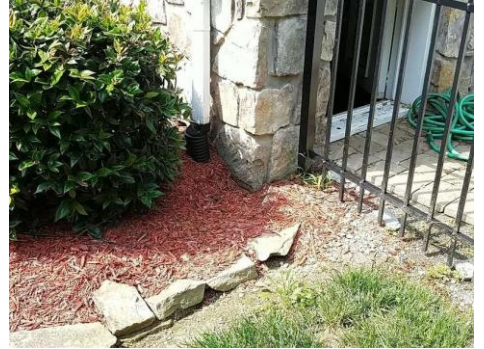
10.5.1 Roof Drainage Systems

There are signs of gutter overflow. The gutters should be properly cleaned and maintained to ensure water is diverted away from the sides of the home and the foundation.

Contact a qualified gutter contractor
