INSPECTION REPORT

# SUMMARY

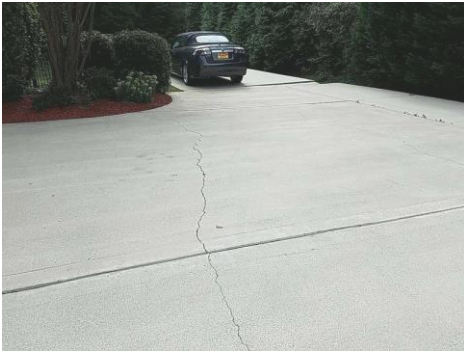
#### Walkways and Driveways: Common Settlement Cracks

Settlement cracks are common to occur and typically are not a reflection of a significant concern. I recommend keeping all cracks sealed to discourage water entry and further cracking and deterioration.

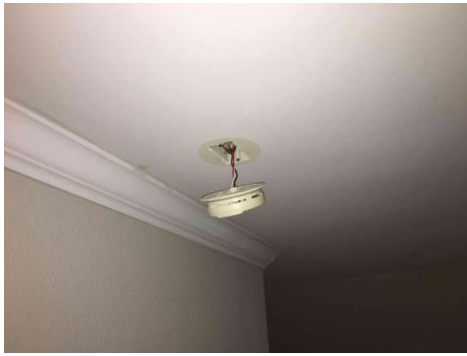
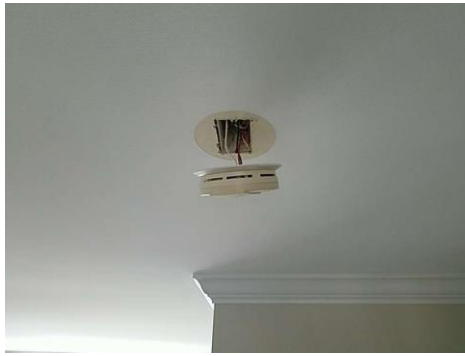
5.7.1 Smoke Detectors

Concern

Recommendation

Contact a qualified handyman.

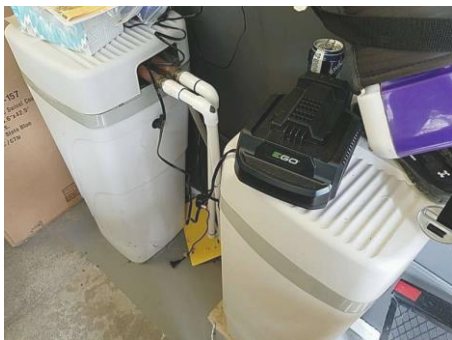
The water softener system in the garage is no longer connected to the plumbing system and is not in service. Consult with the owner to inquire if the system is intended to be removed prior to closing.

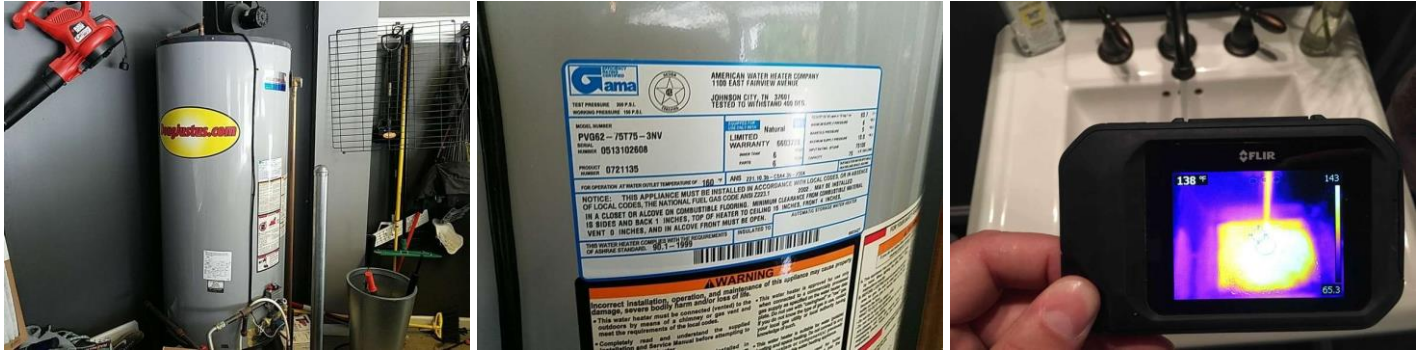
**Water Heater: Nearing or Past Average Life Expectancy**

The unit is nearing or has exceeded average life expectancy.

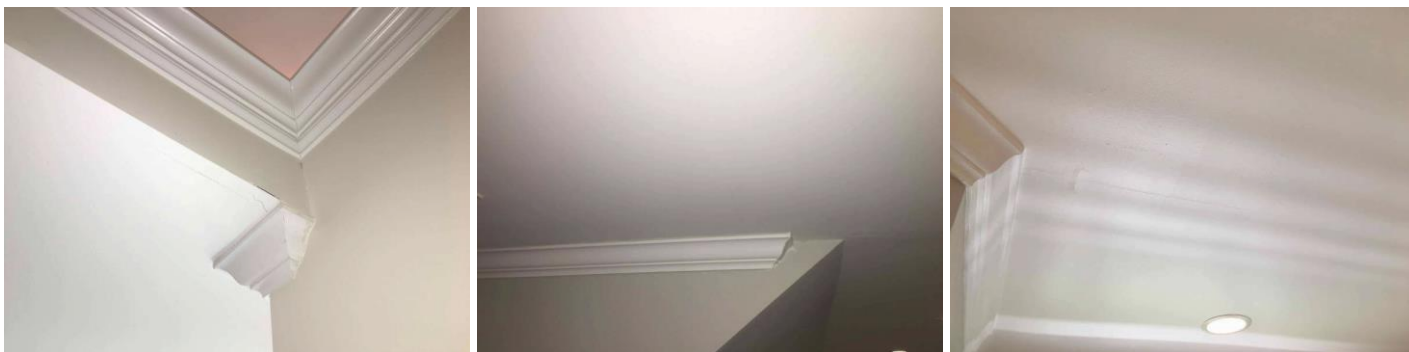
### Walls and Ceilings: Settlement Cracks, Nail Pops, and/or Loose Tape Joints

There were settlement cracks, nail pops, and loose tape joints in the drywall at various walls and ceilings. The cracks, loose tape joints, and nail pops, are common to occur due to normal settling and/or to the expansion and contraction that occurs when heating and cooling the home.

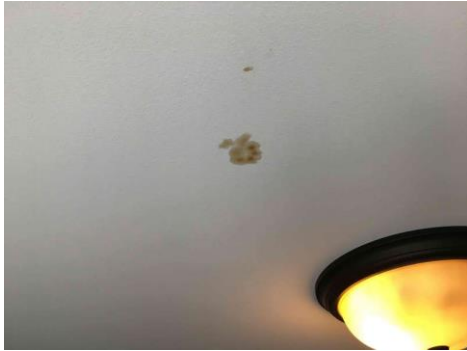
Upper Level Bedroom

There is a stain on the ceiling in the rear guest bedroom. This appears to be a surface stain and is not an indication of any previous leak or concern. The stain can be cleaned / removed and the ceiling re-painted as necessary.

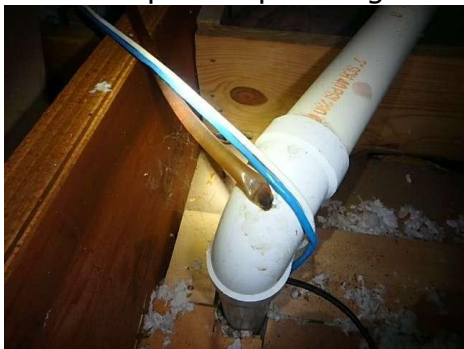
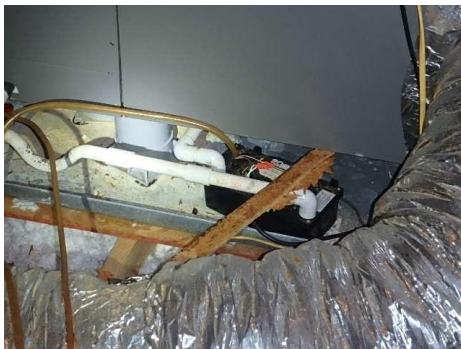
The condensate drain tube is connected to the plumbing vent pipe in the attic. The tube is kinked where connected into the vent pipe, which raises concern for the line to clog and crack. In addition, the drain tube does not have a proper fitting where attached to the vent pipe.

Contact a reputable plumbing company to make necessary repairs to the piping for best functionality and to prevent future concern.

Contact a qualified plumbing contractor.

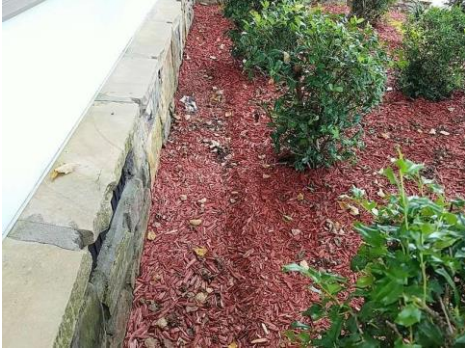
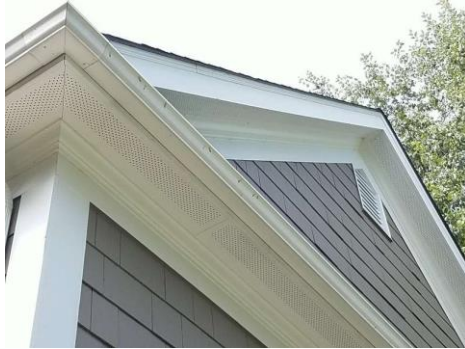
There are signs of gutter overflow. The gutters should be properly cleaned and maintained to ensure water is diverted away from the sides of the home and the foundation.

Contact a qualified gutter contractor

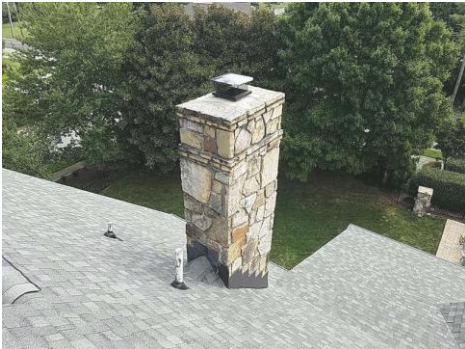
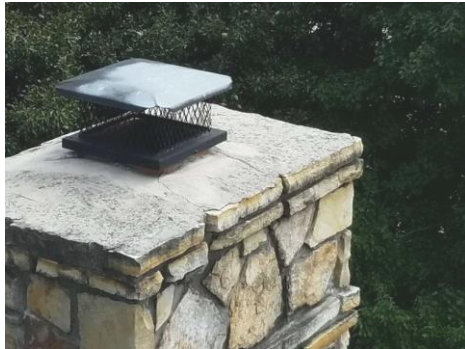
### 10.6.1 Chimney

The open joints in the mortar on the chimney should be sealed to discourage water entry and further deterioration.

Contact a qualified chimney contractor.

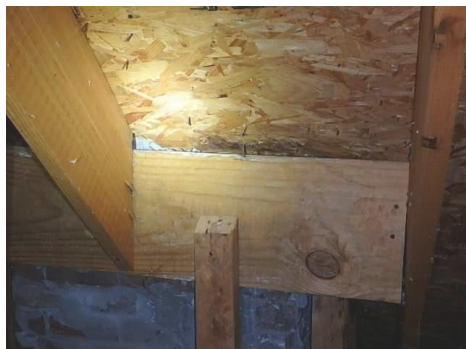
There were signs of previous leaks in the attic. All accessible areas were tested with a moisture meter and no moisture was detected unless otherwise specified in this report.

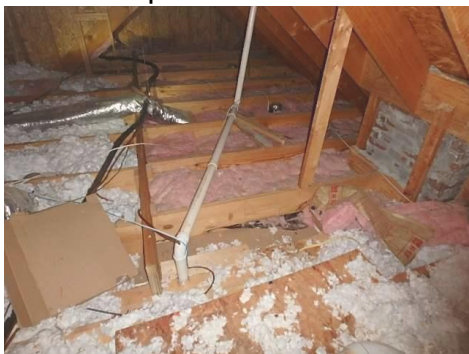
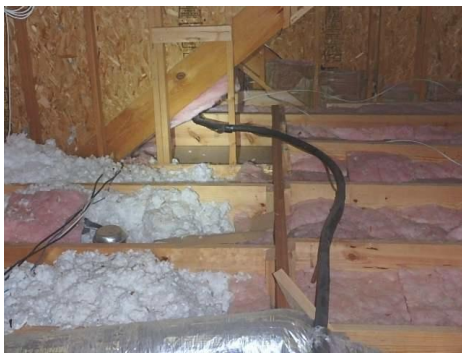
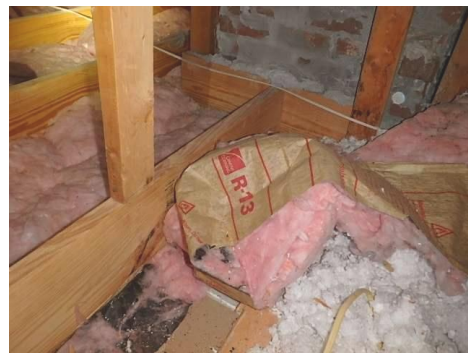
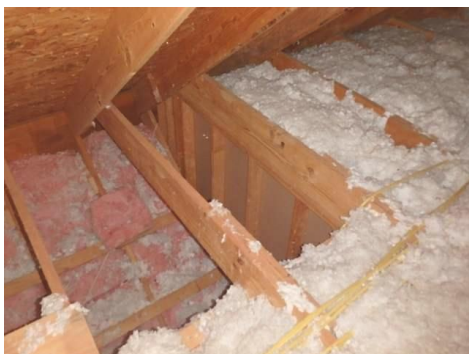
There are areas in the attic that are not properly insulated. This will reduce energy efficiency. I recommend adding or repairing the missing or weak insulation so that all areas are properly insulated for best efficiency. NOTE: current standard for attic insulation is R38.

Contact a qualified insulation contractor.

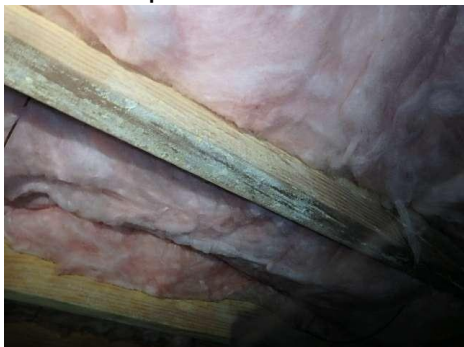
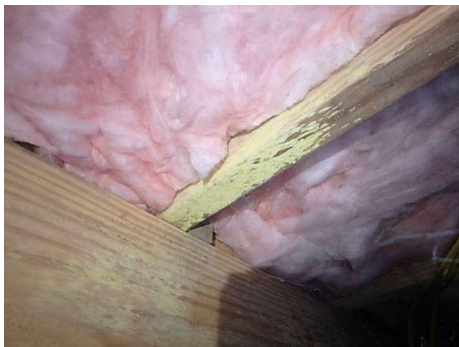
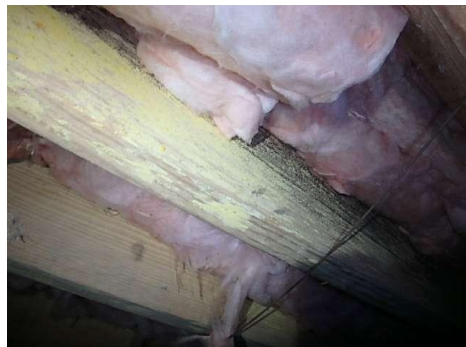
There is fungus on the framing at various locations in the crawlspace. This is an indication of elevated humidity / moisture levels. I recommend contacting an environmental contractor for further review and for possible methods of correction (removal and treatment of the fungus) and prevention (addressing the cause of elevated humidity levels).

Contact a qualified environmental contractor

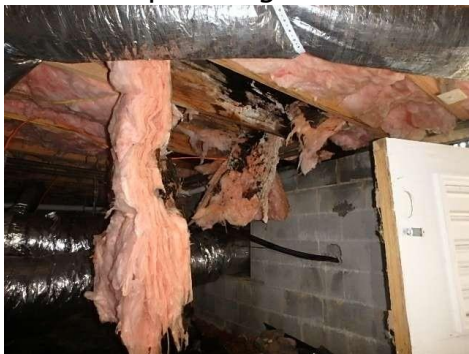
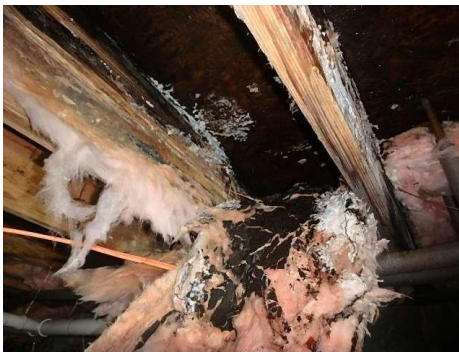
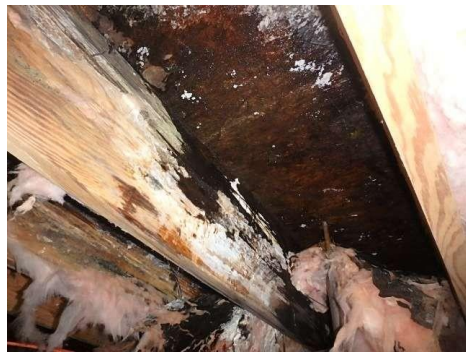
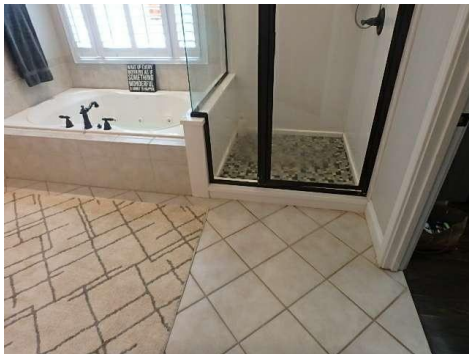
12.3.1 Framing

**DAMAGED FRAMING**

There was water leaking from the floor system below the master bathroom shower stall at the time of this inspection. The framing below the shower is saturated and there is deterioration to the wood. I recommend contacting a reputable contractor to make all necessary repairs to the shower and framing.

Contact a qualified general contractor.

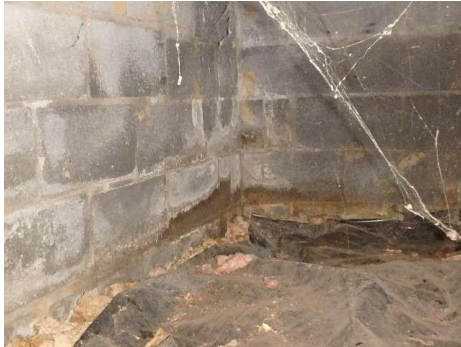
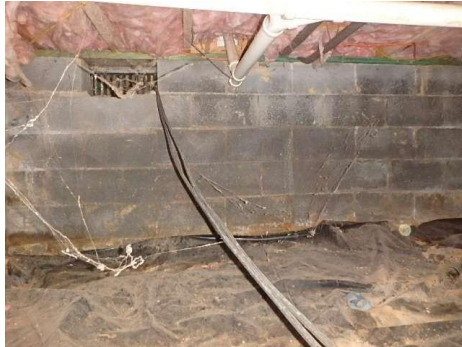
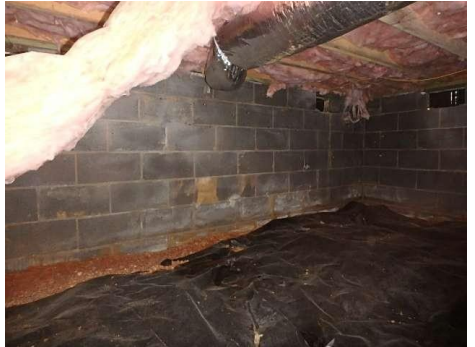
12.4.1 Foundation Walls

**MOISTURE ON FOUNDATION WALLS**

There were isolated areas in the crawlspace that were stained by moisture (some moisture was present during this inspection).

I recommend making necessary effort to divert water away from the foundation. Keep the gutters maintained so that water from the roof will be diverted away from the structure. Adjusting the soil in the flower beds could help to divert surface water away from the structure.

Contact a qualified professional.
